City of Newark, New Jersey
Feasibility Study

POLLUTION ABATEMENT PROGRAM

Clinton Bogert Associates
Consulting Engineers

September, 1978
Revised January, 1979

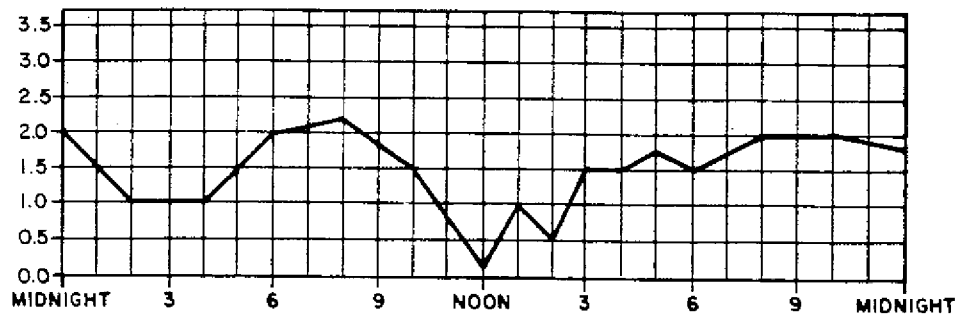
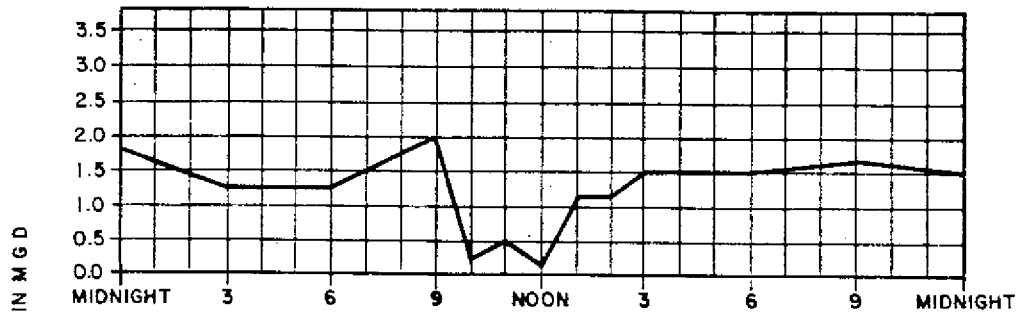
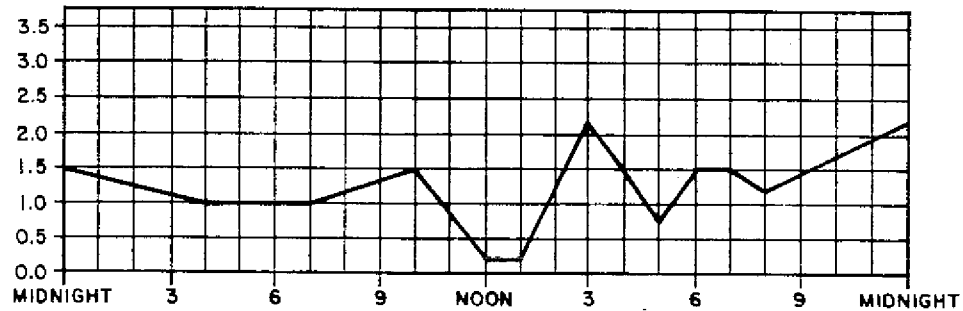
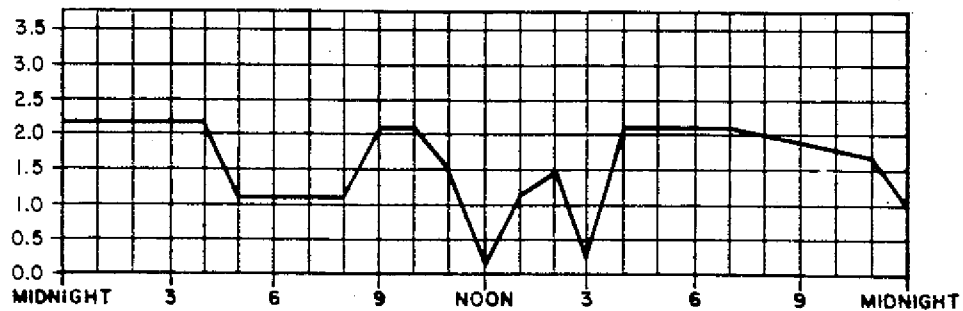
DIURNAL SEWAGE FLOW PATTERNS

The flow rates determined in the Roanoke outfall sewer during the period April 24, 1978 to May 30, 1978 are shown on Plates 3 & 4. These rates have been corrected to eliminate tidal effects. Minimum flow rates were found about noon with higher rates in the morning and afternoon. The flow meter data was supplemented by instantaneous measurements obtained before, during, and after the meters were

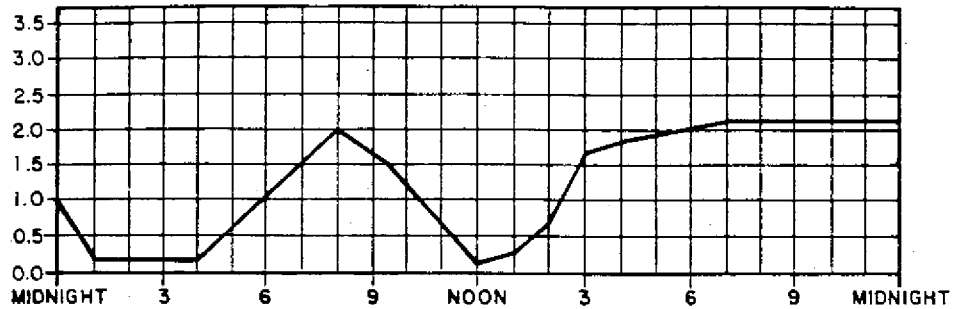
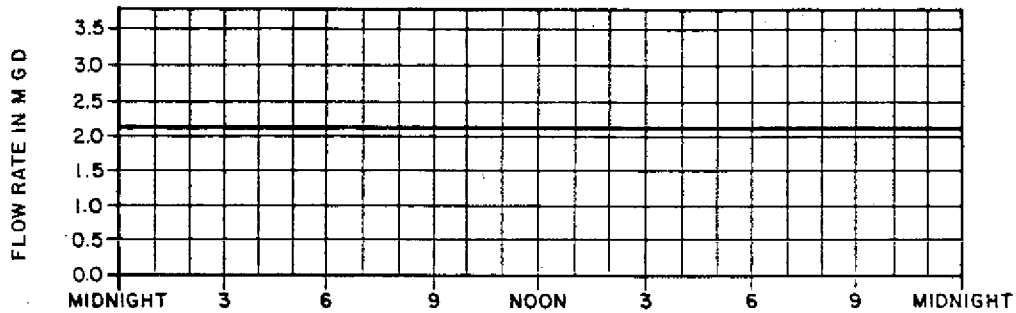
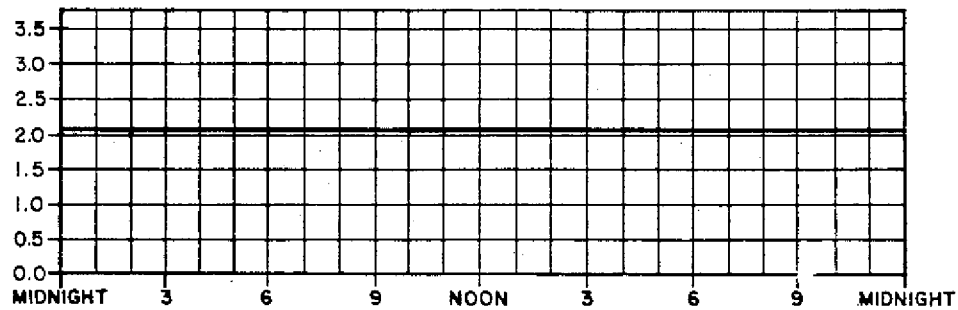
DIURNAL SEWAGE FLOW PATTERNS
ROANOKE AVENUE OUTFALL SEWER

installed. Maximum peak dry weather flow rates of 2.2 mgd and minimum flow rates of 0.2 mgd were recorded. The apparent constant flow rate over the weekend (April 29 and April 30) cannot be explained. The flow meter was checked on Thursday April 27 and found to be operational. On Monday, May 1, the battery and chart were changed and the calibration was checked. No errors in calibration or timing were noted and that meter remained in service during the next week. Similar uniform and high discharges occurred at other unusual times for shorter periods. Most of the flow in this sewer is discharged by two companies, Arkansas Chemical and Sun Chemical. Unusual flow patterns may result from variations in processes and work shifts at these plants.

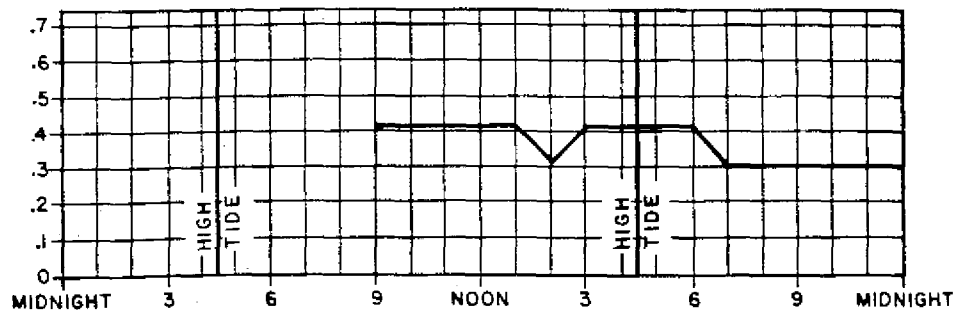
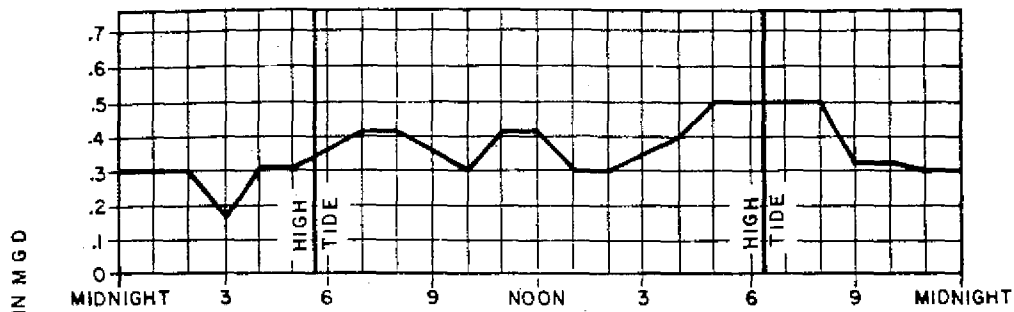
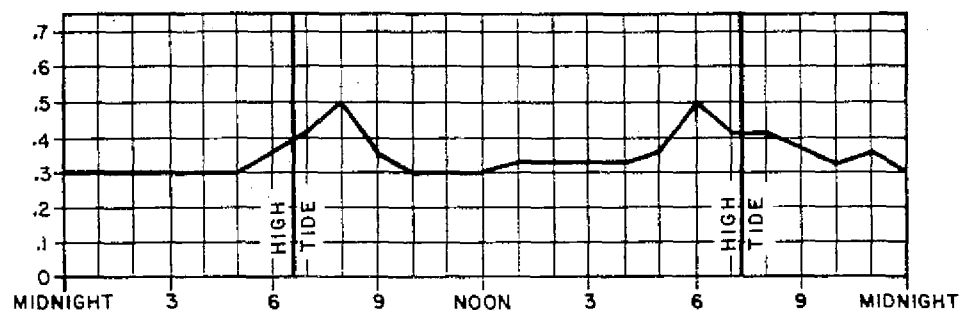
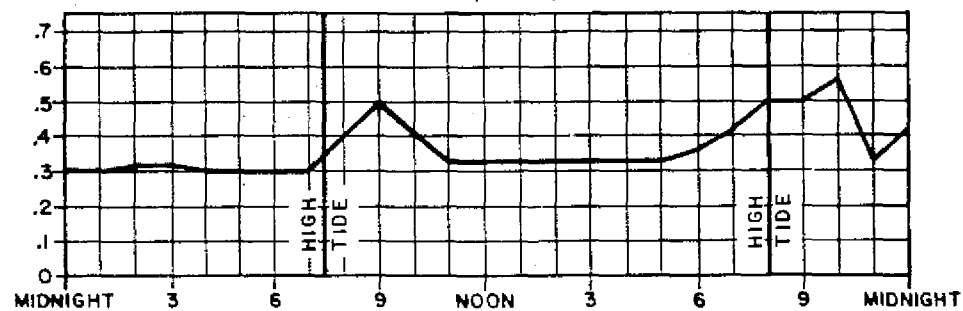
DIURNAL SEWAGE FLOW PATTERNS

Plates 5 and 6 show diurnal flow patterns recorded in the Doremus Avenue interceptor during the period May 1 to May 5. The flow meter malfunctioned on May 6 and no readings were obtained over the weekend. Weekend data for April 22 and April 23 was included to show the effect of antecedent rainfall and springtides on the flow rate in the sewer. The flow on April 22 was about double that of the preceding dry days. The consistency with which higher flow rates coincide with higher tide periods indicates probable inflow caused by tide related fluctuations. About two inches of rain fell on April 19, saturating the ground and raising the river level. At 8:15 PM on April 22, the tide crested one foot above normal and flow in the sewer increased from below 0.8 mgd to 1.1 mgd. Weekday flow rates generally fluctuate between 0.3 and 0.4 mgd with peaks of 0.5 mgd occurring at the times of high tide. The lowest flow rate measured was approximately 0.2 mgd.

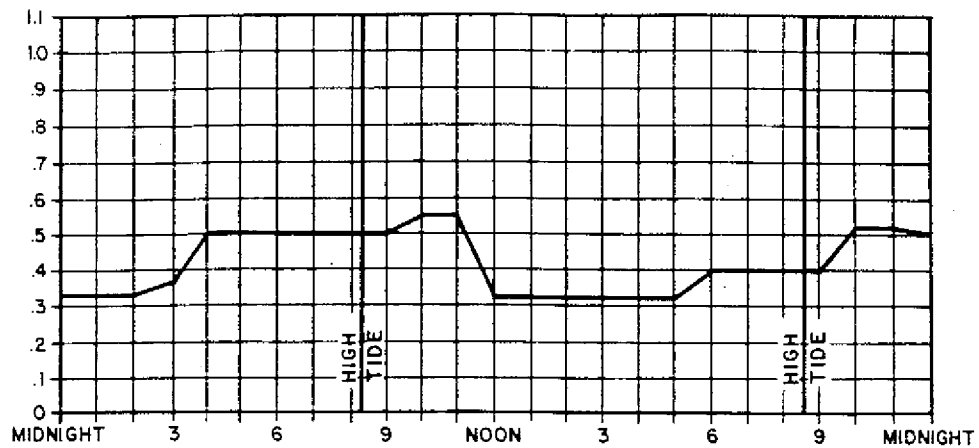
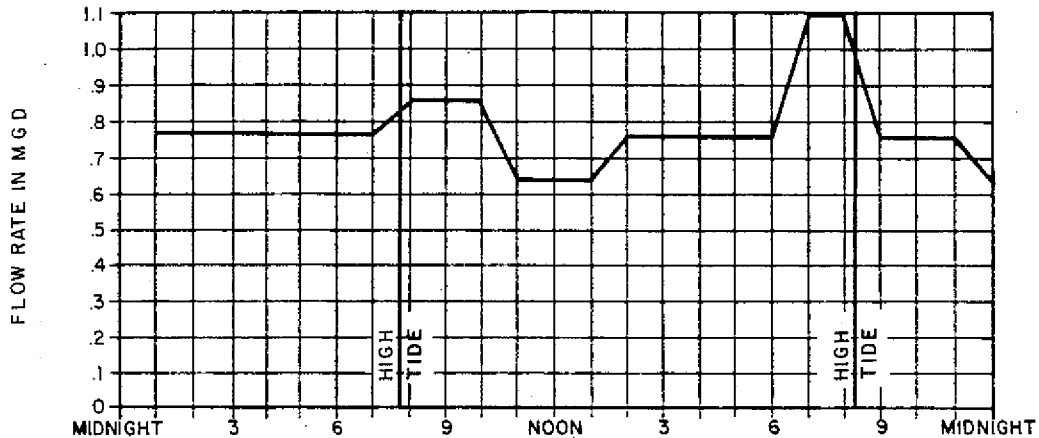
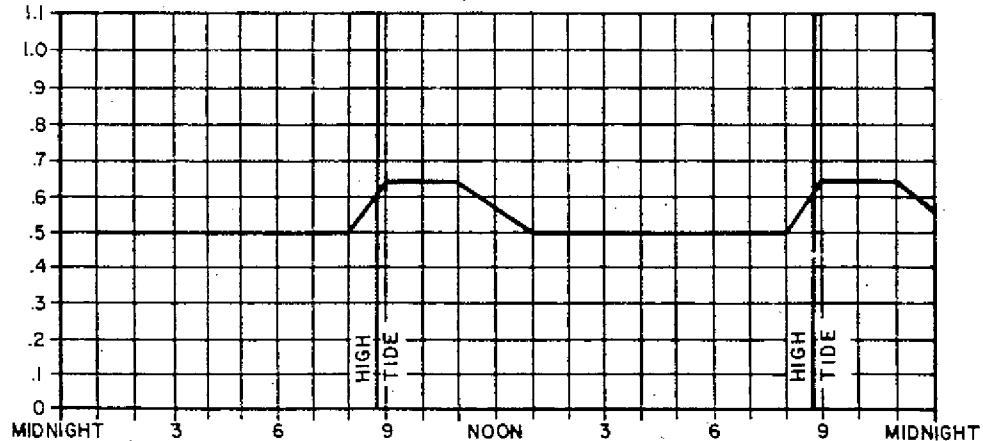
DIURNAL SEWAGE FLOW PATTERNS

NOTES:
1- FLOW METER MALFUNCTIONED
ON 5/6
2- SPRING HIGH TIDE AT
8:15 PM ON 4/22

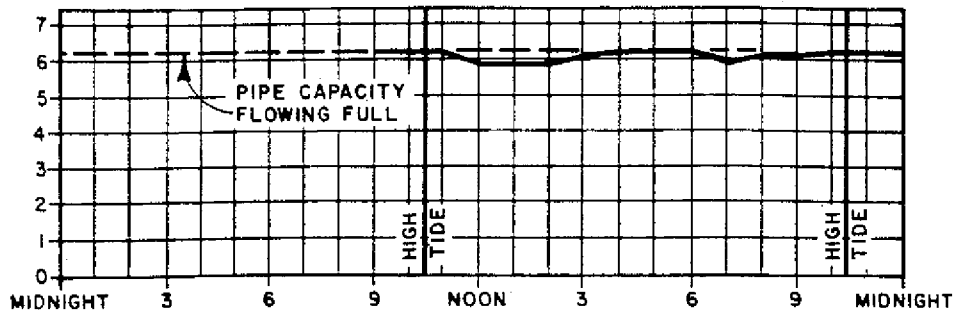
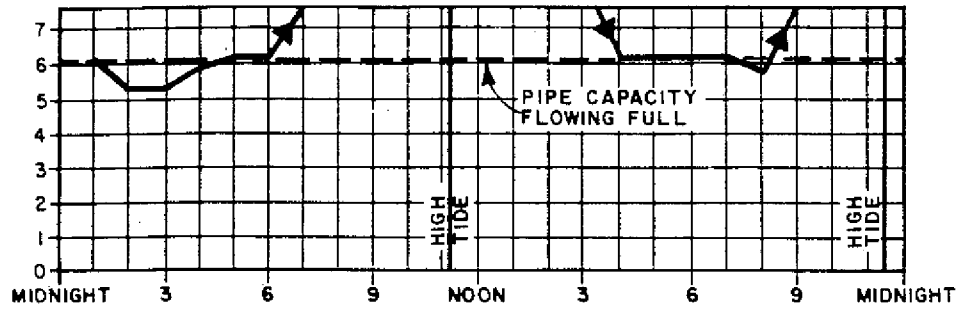
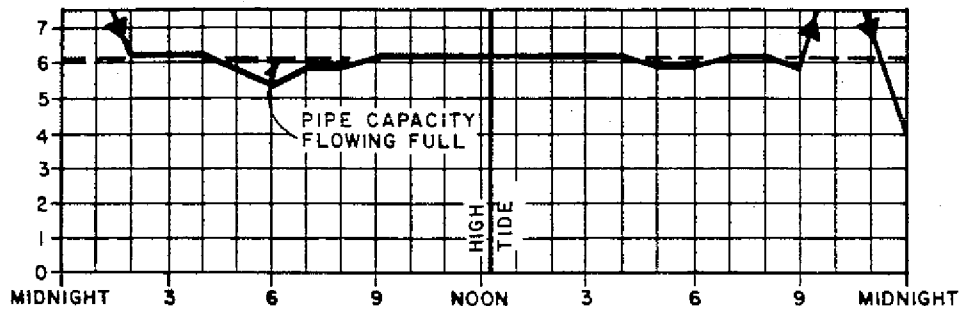
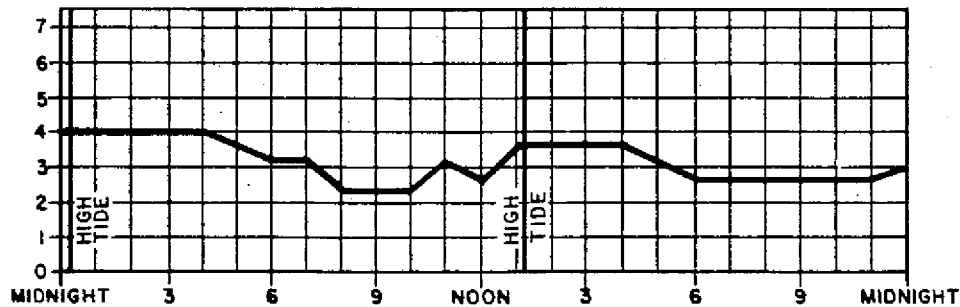
As indicated by the measured flows between 10 and 11 p.m. of May 25, higher peak dry weather flows in the Wilson Avenue interceptor than those of May 23 may be probable. With a field verified sewer gradient between manholes W-9 and W-8 of 0.0025 ft/ft the flow-full capacity of the Wilson interceptor closely approximates 6.2 mgd. The peak capacity of 4.5 mgd, cited in the PVSC Infiltration/Inflow Analysis, was computed for a monitoring point approximately 1500 feet downstream of manhole W-8. This sewer is now being resurveyed by E.T. Killam Associates to verify both the estimated capacity and amount of I/I.

- 1- RAINFALL OF 2.75" ON 5/24 AND 5/25
- 2- FLOW RATES ABOVE 6.2 MGD INDICATE SURCHARGED PIPE

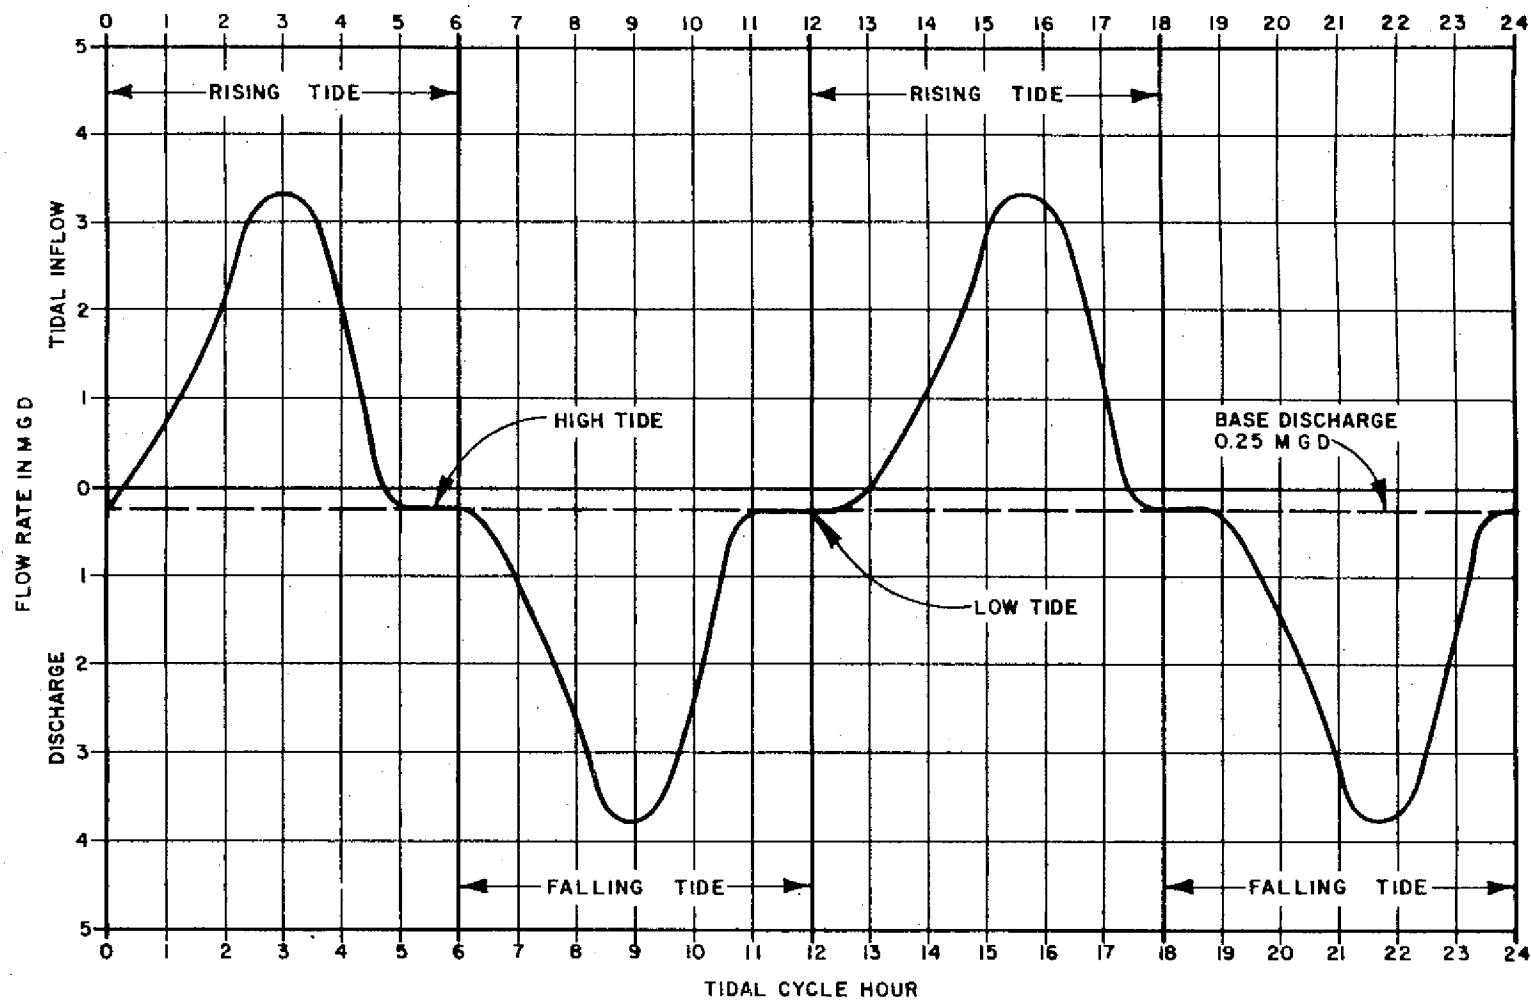
FLOW RATES AT THE
LISTER AVENUE TIDE GATE CHAMBER

There was no evidence of chemical attack or deterioration of the concrete chamber. Sediment in the invert of the chamber prevents the Lister Avenue tide gate from closing completely. The gate allows inflow during the rising tide. Assuming a five foot tidal range and an open tide gate, approximately 270,000 gallons of river water enters with each incoming tide, mixes with pollutants being discharged into the system and flows back into the river as the tide falls. A typical diurnal flow pattern at the tide gate is shown on Plate 9. If
